SUBJECT: AS-503 S-IVB LOX Tank
Overpressurization Problem
Case 320

DATE: December 31, 1968

FROM: A. Bresnick

MEMORANDUM FOR FILE

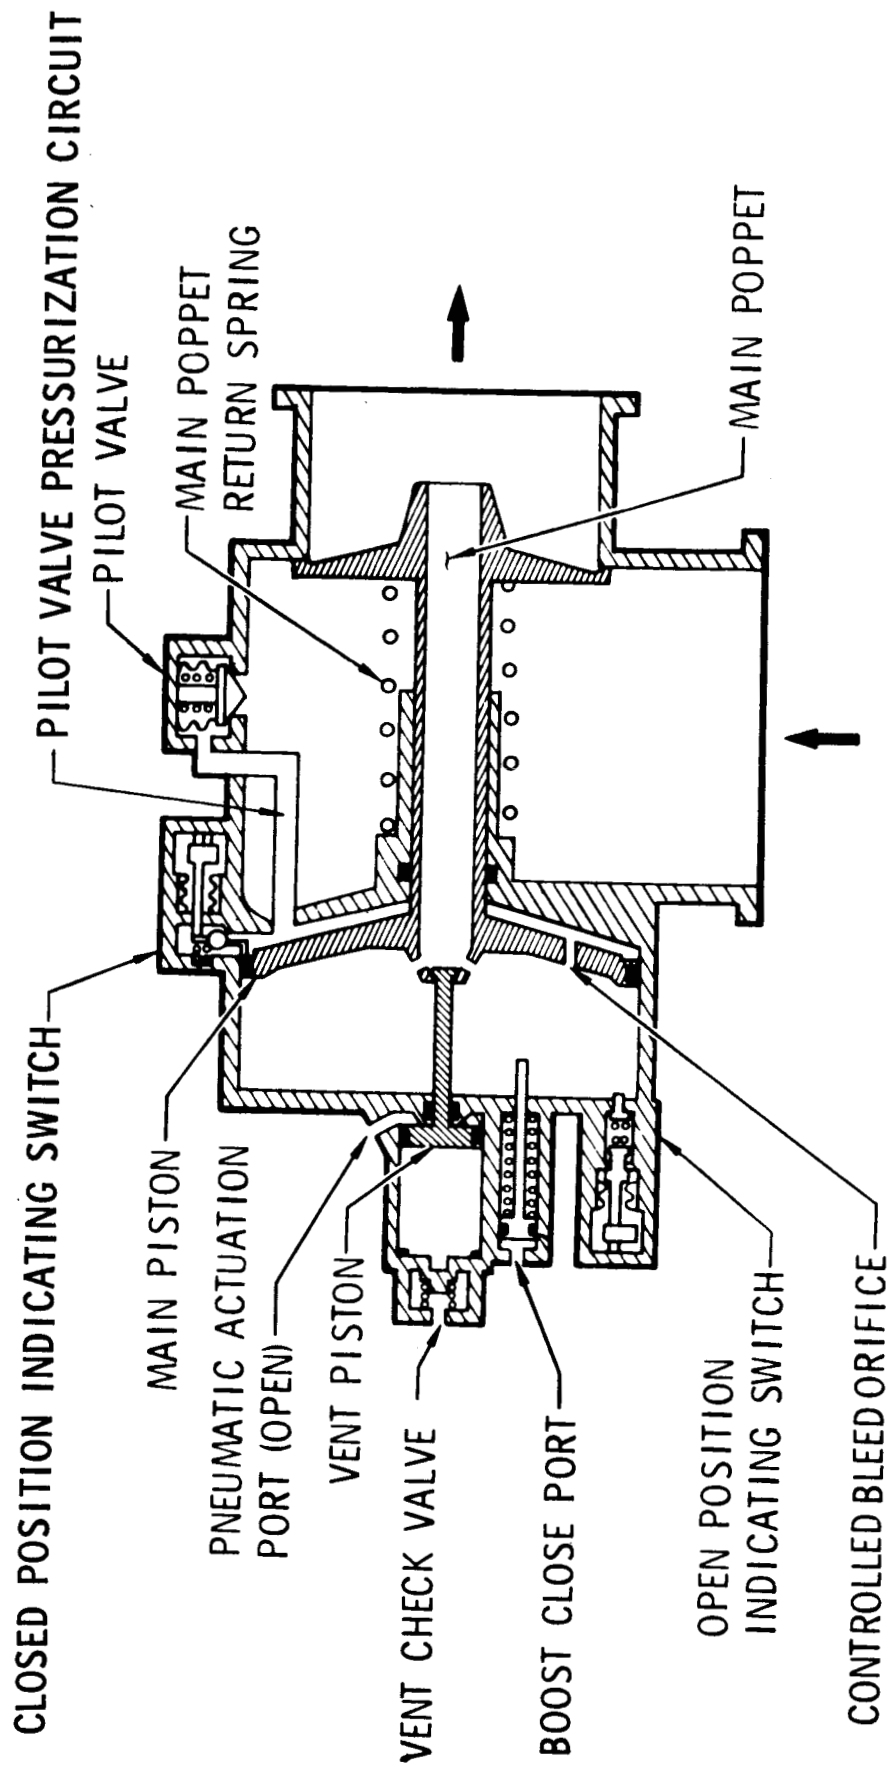
FIGURE 1 - LOX TANK VENT AND RELIEF VALVE (SCHEMATIC)

A new mission rule for S-IVB LOX tank overpressurization prior to S-IVB ignition was implemented for AS-503. If tank overpressurization were to occur the crew would abort prior to LET jettison, and would upstage to the S-IVB after LET jettison. S-IVB LOX tank overpressurization could occur due to any failure which prevented closing of either S-IVB LOX tank pressurization cold helium supply shutoff valve. With continuous cold helium flow into the tank, the ullage pressure would rise to the relief setting of the two vent valves. The vent valves, which are pilot operated, would continue to vent the gas mixture in the ullage space until the cold helium chilled the GOX-helium mixture to a low enough temperature to cause the GOX to freeze. If this were to occur, the frozen GOX could clog the vent valve pilot circuits (Figure 1), lowering the valve main piston actuation pressure causing the vent valves to close.

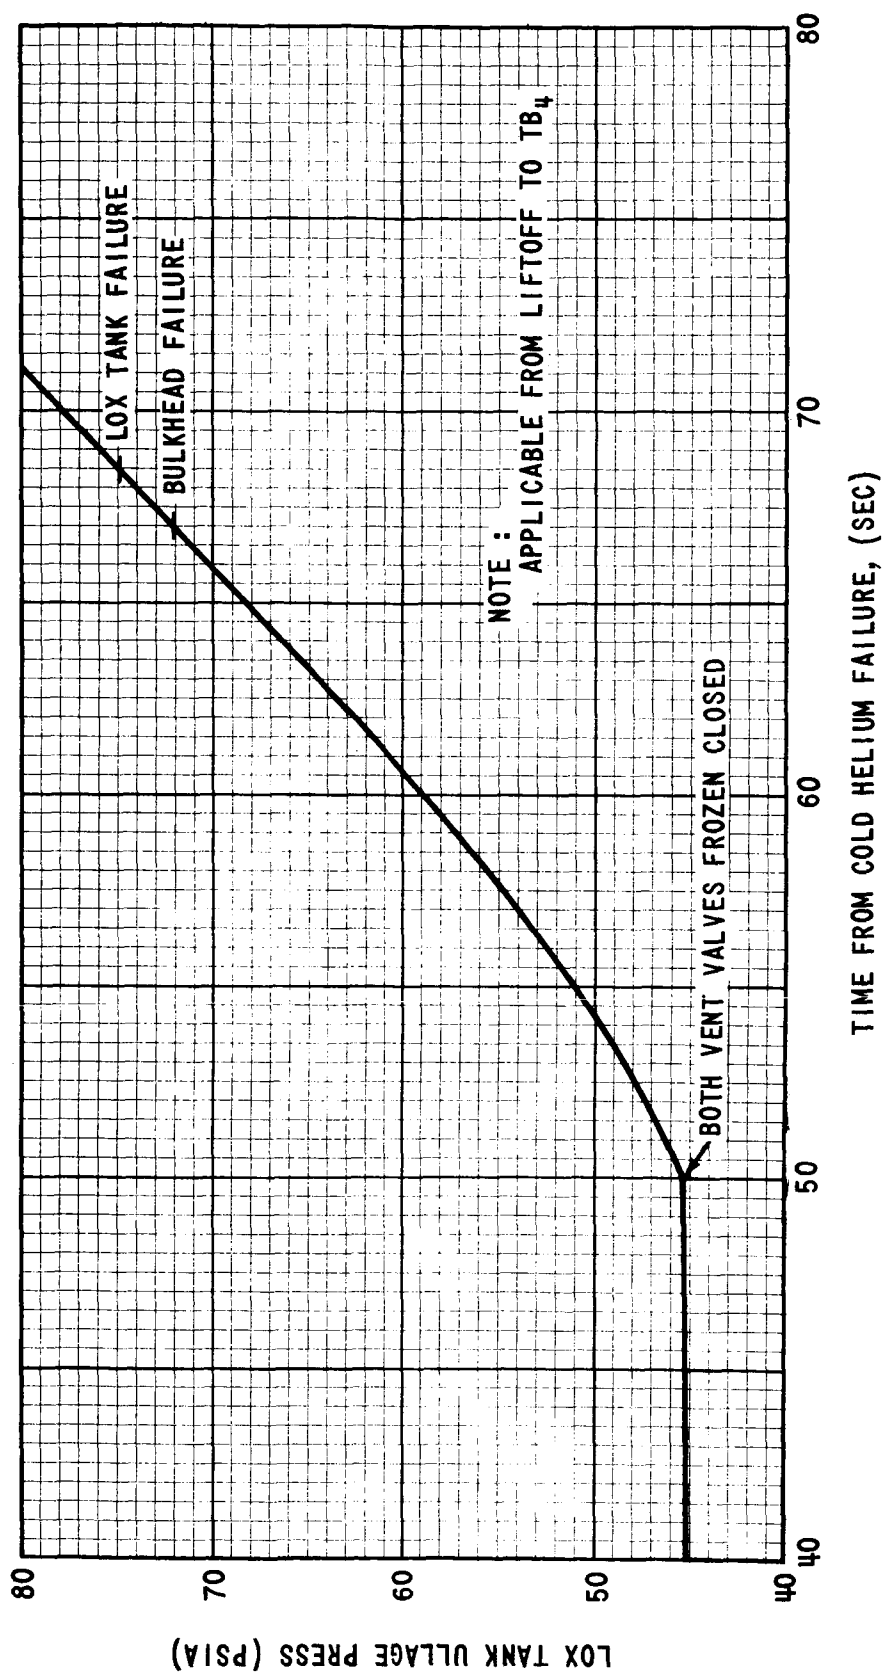
FIGURE 3 - S-IVB-503 COLD HELIUM SYSTEM FAILURE LOX
TANK ULLAGE PRESSURE HISTORIES

Figure 3 shows a typical S-IVB LOX tank ullage pressure profile (calculated). The figure shows the delay time of 50 seconds expected from the cold helium shutoff failure until both vent valves freeze closed and the pressure buildup begins. With both vents closed, the tank pressure is seen to rise at a rate of about 1.7 psia/second. At this rate the bulkhead would fail in 17 seconds.
